AN EVALUATION OF HEATING AND EROSION IN THE 105mm XM204 HOWITZER AND 155mm M185 CANNON

Calspan Technical Report No. VL-6050-D-1

PICATINNY ARSENAL DOVER, NEW JERSEY

APRIL 1977

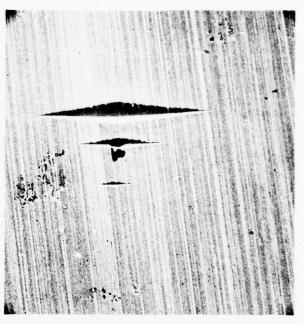
Figure 1 COMPARISON OF STEEL EROSION SENSORS FOR M119 AND UNMODIFIED XM 201 E2 CHARGES (200X)

SENSOR FOR GROUP 2 (M119) BEFORE FIRING

SENSOR AFTER FIVE M119 SHOTS

SENSOR FOR GROUP 8 (STD. XM 201 E2) BEFORE FIRING

SENSOR AFTER FIVE (STD. XM 201 E2) SHOTS

The steel sensors for these designs compare favorably with that of the M119 (Figure 1). A comparison of Figures 4 and 2, showing the surface condition of the Inconel sensors, clearly demonstrates the improved performance of these mods over that of the unmodified XM201E2 as well as their degree of approach to erosivity of the M119 charge.

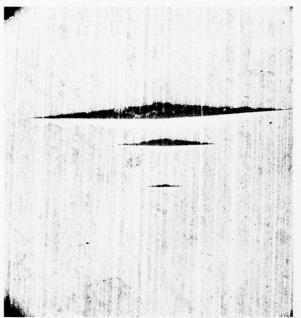
Figure 4 INCONEL SENSOR CONDITION BEFORE AND AFTER FIRING FOR TWO XM 201 E2 MODS INVOLVING INCREASED WEAR ADDITIVE (200X)

SENSOR FOR GROUP 6 (120Z JACKET) BEFORE FIRING

SENSOR FOR GROUP 6 AFTER THREE SHOTS

SENSOR FOR GROUP 5 (190Z LINER) BEFORE FIRING

SENSOR FOR GROUP 5 AFTER THREE SHOTS

it is recommended that consideration be given to modification of the XM201E2 charge through the addition of a 0.5 oz. black powder spot to the basepad and change to a 19 oz. internal wear liner.

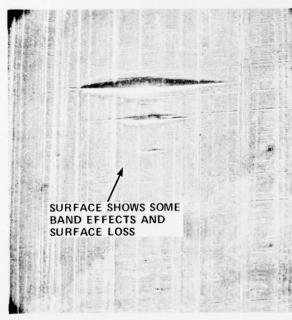
Figure 5 SURFACE CONDITION OF VASCOMAX SENSORS BEFORE AND AFTER FIRING FIVE M67 SHOTS (200X)

In an attempt to formulate a basis upon which each charge could be ranked with regard to erosivity, erosion sensor condition after test was characterized through analysis of several factors. First, the surface loss was estimated by careful observation of surface quality and impression length change. Resulting estimates are given in Table I. Photographs from which these surface loss estimates were based are shown in Figures 5 through 7.

TYPICAL "KNOOP" PATTERN BEFORE FIRING

SENSOR AT 39.6 CM AFTER FIVE SHOTS

SENSOR AT 55 CM AFTER FIVE SHOTS

SENSOR AT 70 CM AFTER FIVE SHOTS

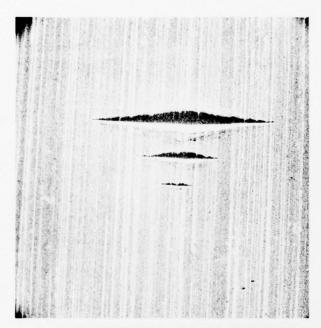
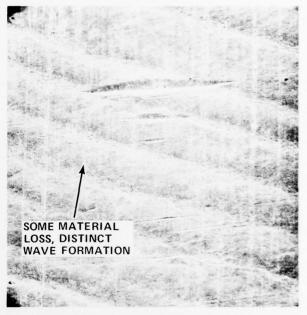
Figure 6 SURFACE CONDITION OF VASCOMAX SENSORS BEFORE AND AFTER FIVE XM 200 SHOTS (200X)

TYPICAL "KNOOP" PATTERN BEFORE FIRING

SENSOR AT 39.6 CM AFTER FIVE SHOTS

SENSOR AT 55 CM AFTER FIVE SHOTS

SENSOR AT 70 CM AFTER FIVE SHOTS

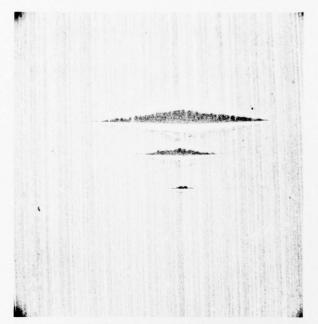
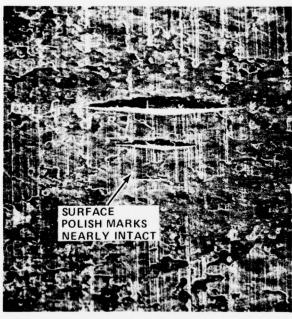
Figure 7 SURFACE CONDITION OF VASCOMAX SENSORS BEFORE AND AFTER FIVE XM 622 SHOTS (200X)

TYPICAL "KNOOP" PATTERN BEFORE FIRING

SENSOR AT 39.6 CM AFTER FIVE SHOTS

SENSOR AT 55 CM AFTER FIVE SHOTS

SENSOR AT 70 CM AFTER FIVE SHOTS

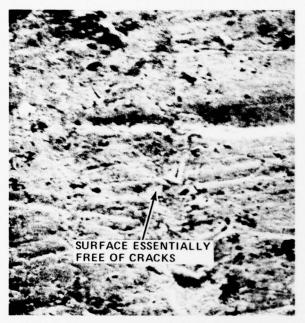
Figure 9 POST TEST SURFACE CRACK PATTERNS FOR VASCOMAX SENSORS LOCATED NEAR THE ORIGIN OF RIFLING (2000X)

Finally, at very high magnification as is shown in Figure 9, each sensor could be inspected for surface cracking. This was accomplished with similar ranking system to the above. Results are given in Table V.

VASCOMAX SENSOR AT 39.6 CM AFTER FIVE M67 SHOTS

VASCOMAX SENSOR AT 39.6 CM AFTER FIVE XM 200 SHOTS

VASCOMAX SENSOR AT 39.6 CM AFTER FIVE XM 622 SHOTS
